## 4-POINT INSPECTION

12345 Sample Run Rd  
Holiday FL 34690

SEPTEMBER 1, 2018

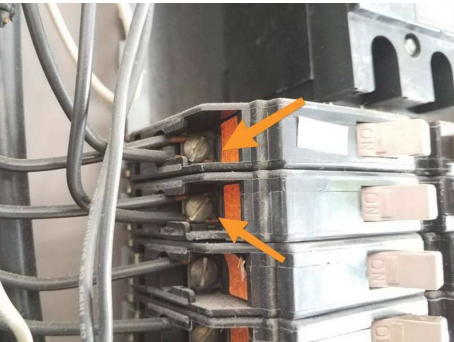
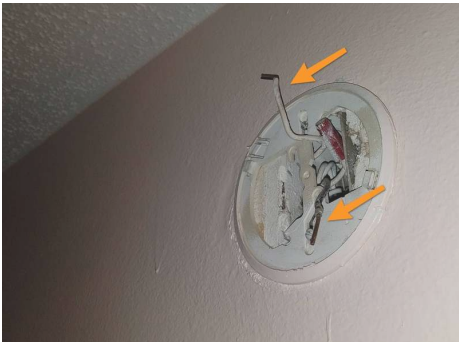
<b>Electrical: System General Condition</b> Unsatisfactory	<b>Electrical: Presence Of Cloth/Aluminum Wiring (and Aluminum repairs):</b> N/A	<b>Electrical: Wiring Type</b> Copper, NM / BX / or Conduit
<b>Main Panel: Type</b> Circuit Breaker	<b>Main Panel: Total Amps</b> 150 Amp	<b>Main Panel: Amperage Sufficient for Current Usage?</b> Yes
<b>Main Panel: Age (In Years)</b> 32 Years	<b>Main Panel: Year Last Updated</b> Original	<b>Main Panel: Brand</b> Cutler Hammer
<b>Blowing Fuses?</b> No	<b>Tripping Breakers?</b> No	<b>Empty Sockets?</b> No
<b>Loose Wiring?</b> No	<b>Improper Grounding?</b> No	<b>Corrosion?</b> No
<b>Double Taps?</b> Yes  Double taps noted at 2 top left 20 Amp breakers.	<b>Exposed Wiring?</b> Yes  Live wiring exposed at hallway smoke detector.	<b>Unsafe Wiring?</b> No

<b>Improper Breaker Size?</b> No	<b>Scorching?</b> Yes  Scorching and heat damage noted to wiring on 15 Amp breaker.	<b>Other? (explain)</b> No
-------------------------------------	--	-------------------------------

Home appeared to be under partial renovations. Consider making recommended repairs by licensed professionals. Then, re-inspect as needed before submitting to insurance.

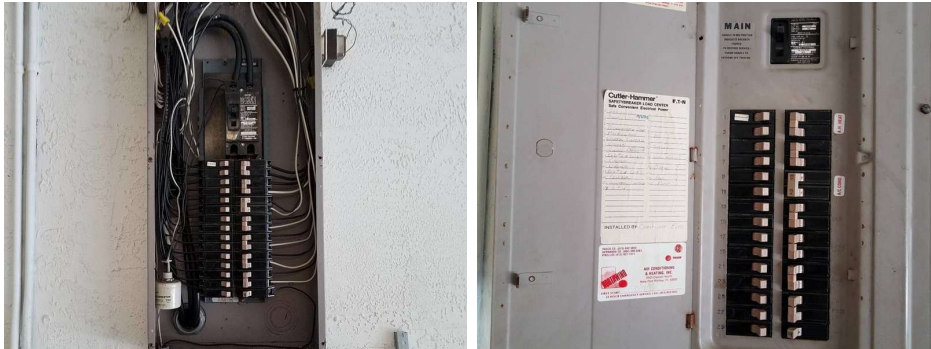
**Main Panel: Photos**

- *Open main electrical panel and interior door*
- *Electrical box with the panel off*

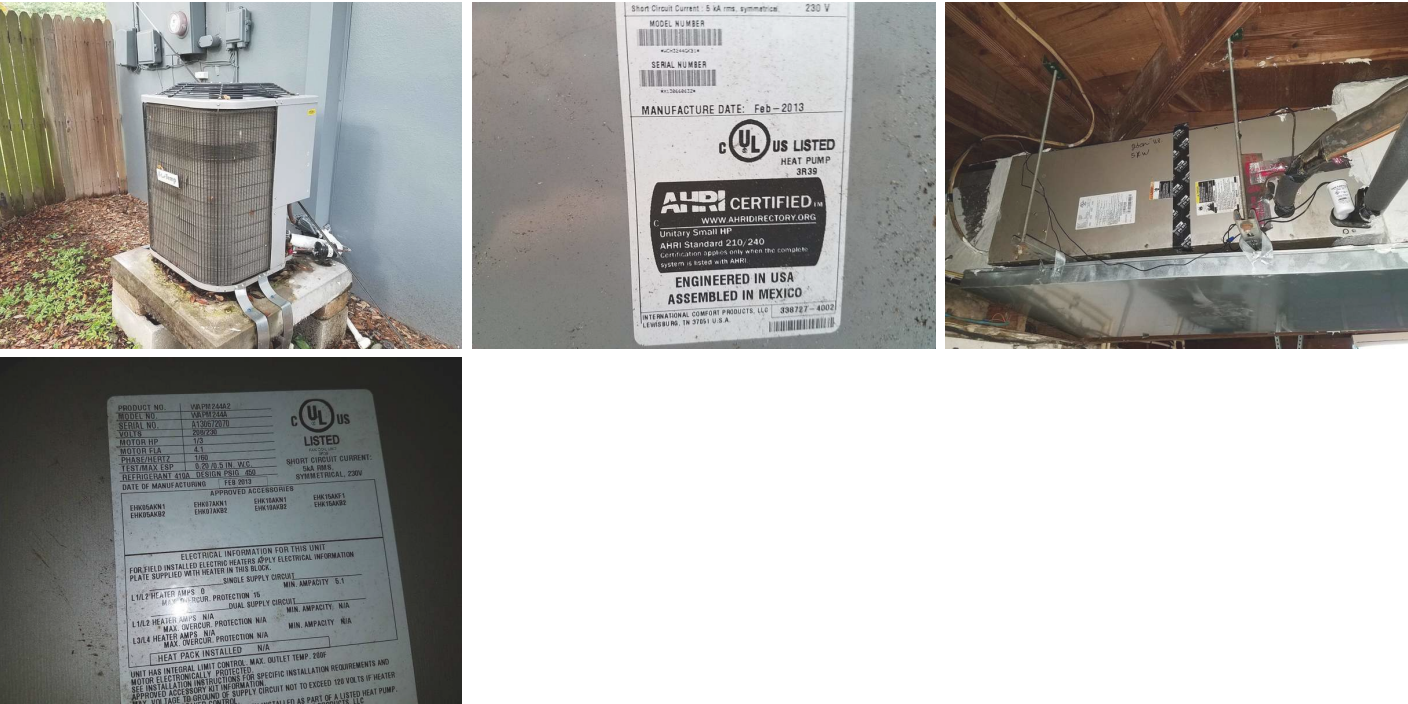
HVAC: Photos  
Photos of HVAC equipment and labels.

<b>HVAC: Central AC</b> Yes	<b>HVAC: Central Heat</b> Yes	<b>HVAC: If not central heat, indicate primary heat source and fuel type:</b> N/A
<b>HVAC: System in Good Working Order?</b> Yes	<b>HVAC: Date of Last Servicing:</b> 3/2017	<b>HVAC: Age of System (in years)</b> 5 Years
<b>HVAC: Year Last Updated</b> 2013	<b>Hazards: Does the air handler/condensate line or drain pan show any signs of blockage or leakage, including water damage to the surrounding area?</b> No	<b>Hazards: Is The Source Portable?</b> No
<b>Hazards: Space Heater Used As Primary Heat Source?</b> No	<b>Hazards: Wood Burning Stove or Central Gas Fireplace Not Professionally Installed?</b> No

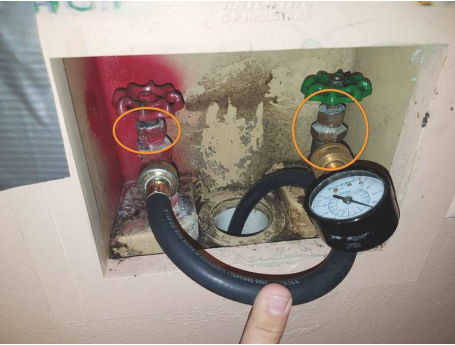
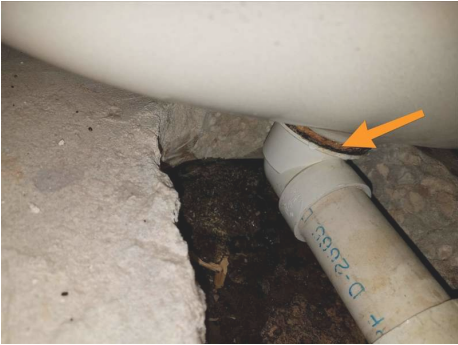
<b>Plumbing: Types of Piping</b> Copper, PVC/CPVC	<b>Plumbing: Age Of Piping System</b> Original <i>If re-piped, provide year and extent of renovation in comments below:</i>	<b>Water Heater: TPR Valve?</b> Yes
<b>Water Heater: Indication of an Active Leak?</b> No	<b>Water Heater: Indication of Prior Leak?</b> No	<b>Water Heater: Location:</b> Garage
<b>Water Heater: Age:</b> Manufactured Date 07/2013	<b>Fixtures &amp; Connections: Dishwasher</b> Satisfactory	<b>Fixtures &amp; Connections: Refrigerator</b> Satisfactory
<b>Fixtures &amp; Connections: Washing Machine</b> Unsatisfactory  Active leak at cold and hot water laundry supplies.	<b>Fixtures &amp; Connections: Water Heater</b> Satisfactory	<b>Fixtures &amp; Connections: Showers/Tubs</b> Unsatisfactory  Leak at 1st bathtub drain line connection.

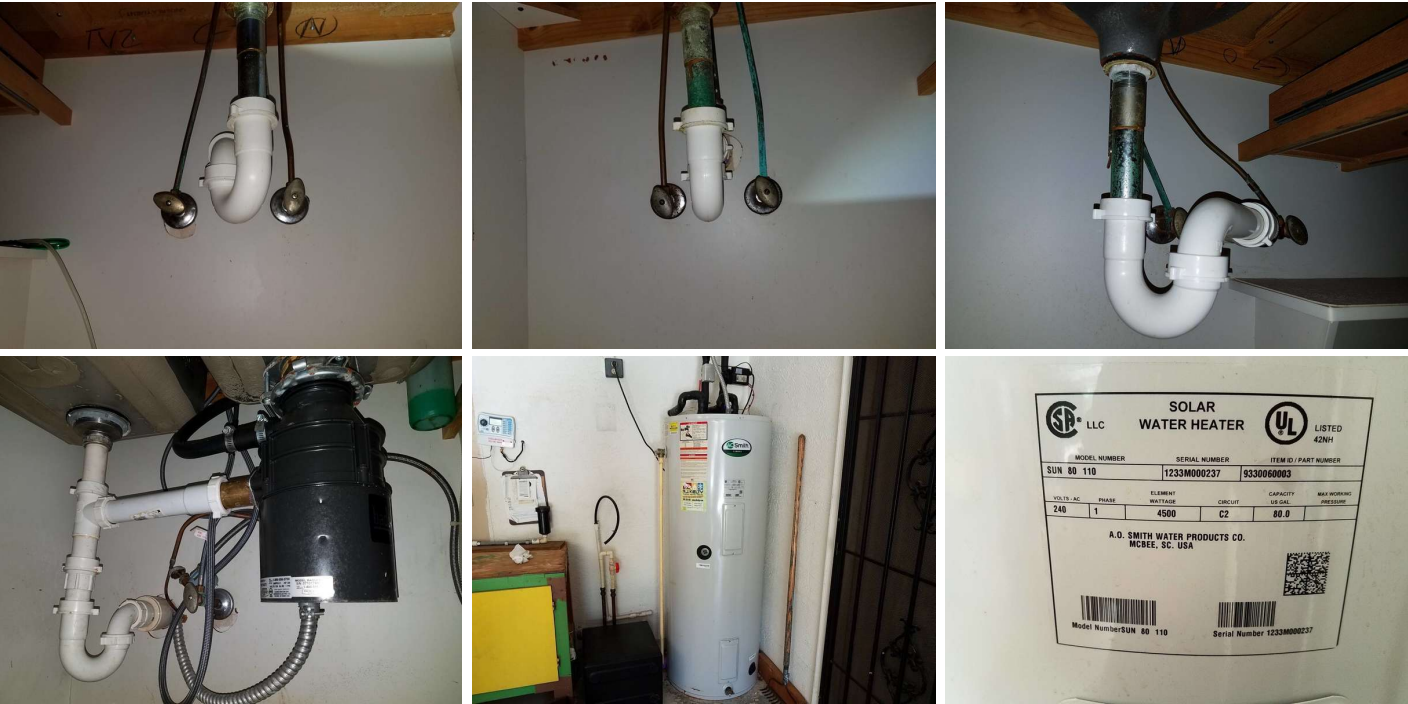
Plumbing: Photos

Plumbing Photos: Water heater, under cabinet plumbing/drains, exposed valves.

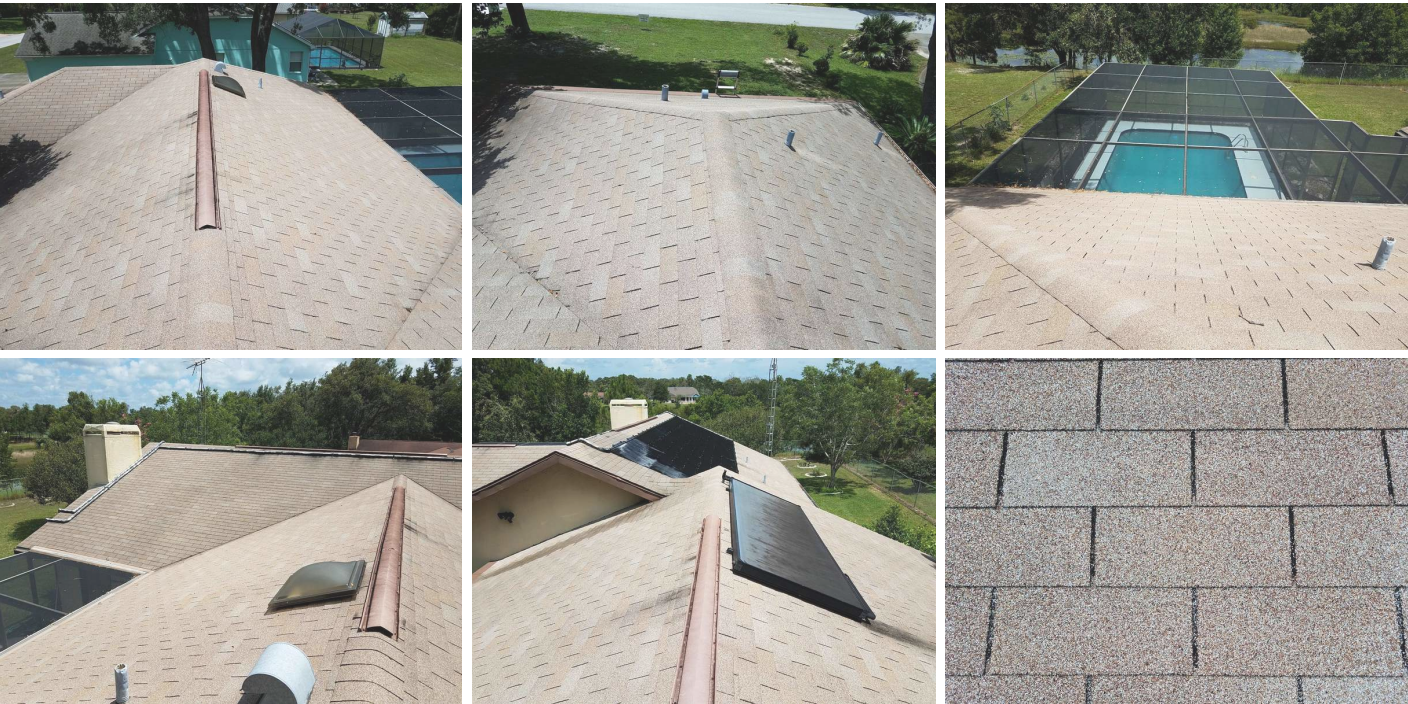
<b>Predominant Roof: Covering Material</b> Shingle	<b>Predominant Roof: Age (in years)</b> 16 Years	<b>Predominant Roof: Remaining Useful Lifespan</b> 4-5 Years
<b>Predominant Roof: Date of Last Permit</b> 11/11/2002	<b>Predominant Roof: Date of Last Update</b> 11/11/2002	<b>Predominant Roof: Updated (Full or Partial)?</b> Full Replacement
<b>Predominant Roof: Overall Condition:</b> Satisfactory	<b>Predominant Roof: Visible Signs of Damage / Deterioration?</b> N/A	<b>Predominant Roof: Visible Signs of Leaks (Attic/Underside of Decking)?</b> No
<b>Predominant Roof: Visible Signs of Leaks (Interior Ceilings)?</b> No		
<b>Predominant Roof: Photos</b> <i>Roof Photos: Photos of each slope</i>
